# City of Middleton, Idaho MUNICIPAL SEPARATE STORM SEWER SYSTEM (MS4) NPDES Permit No. IDS - 028100

# 2015 Storm Water Monitoring Report

Date: January 8, 2016

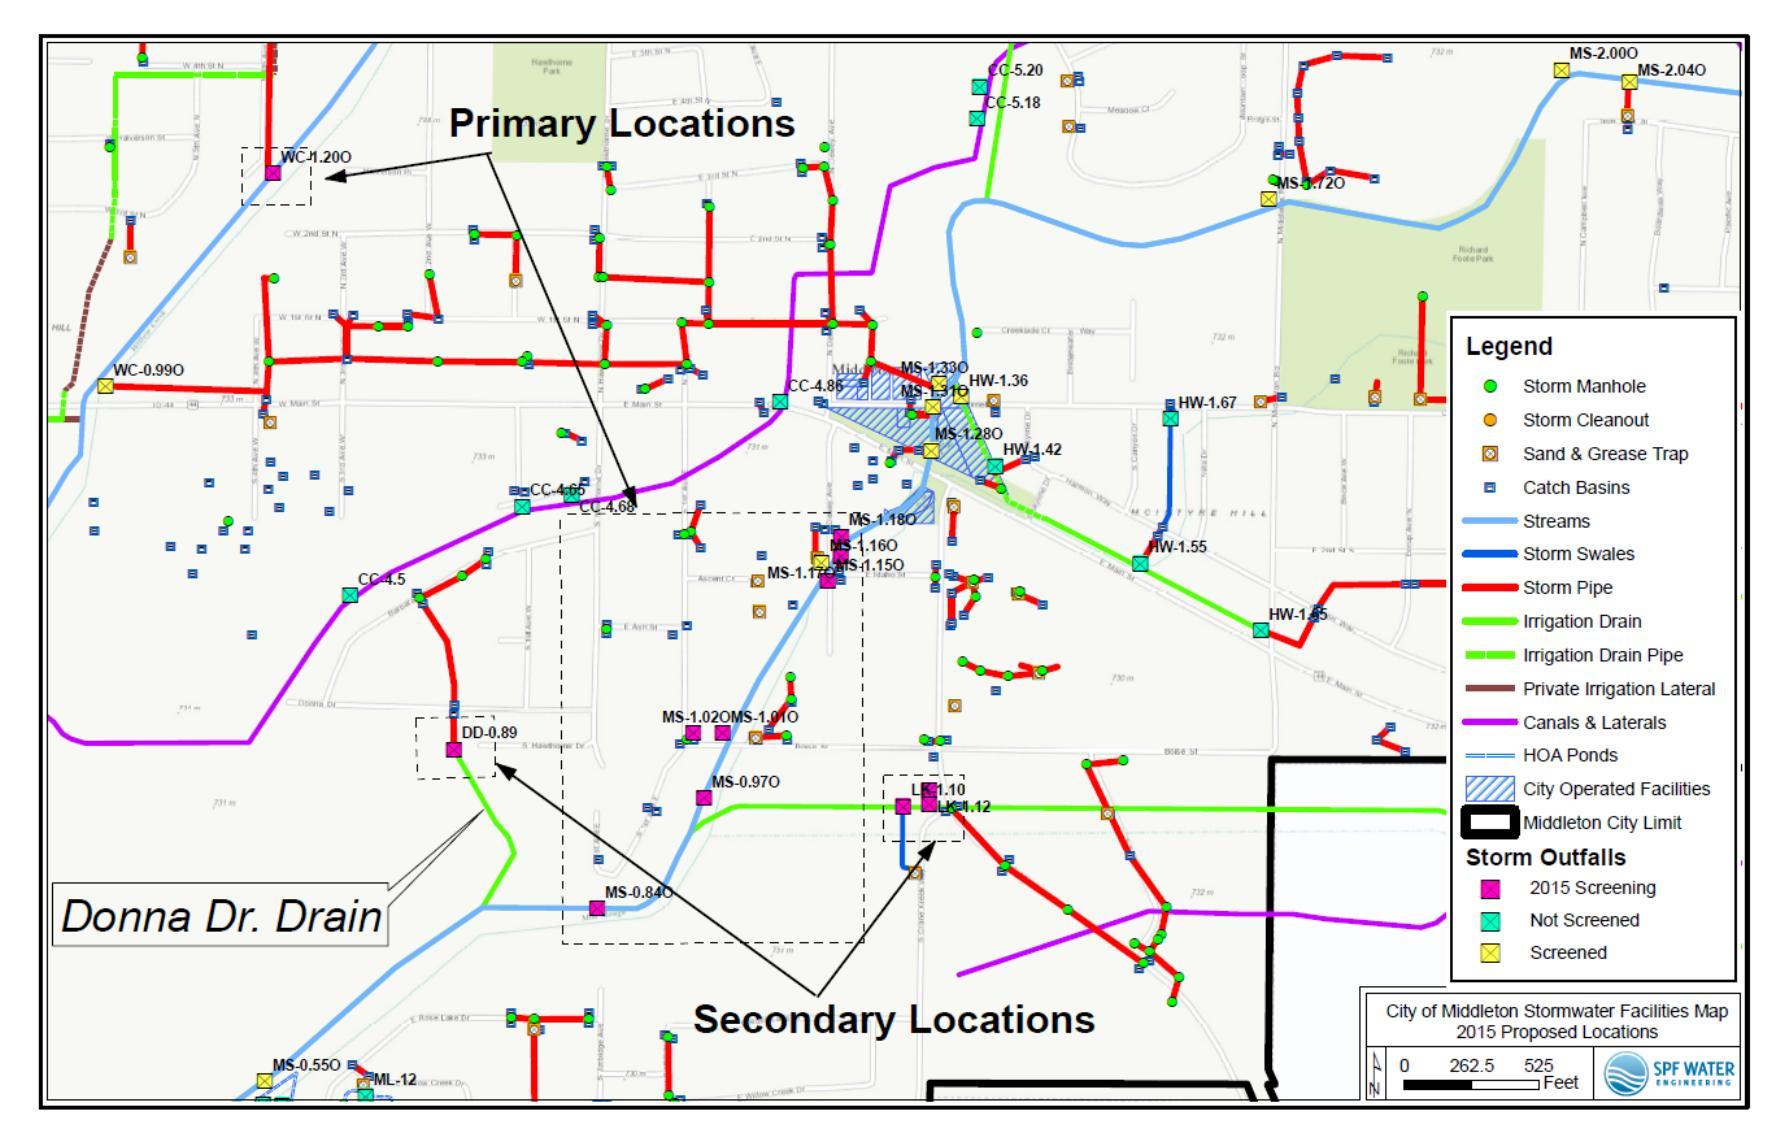
Figure 1. Map showing storm water monitoring and 2015 screening locations.

There are two components to MS4 water quality monitoring: (1) outfall monitoring and (2) dry weather screening. The monitoring and screening locations are shown in Figure 1. The primary focus of the water quality sampling was on total suspended solids (TSS), phosphorus (TP), and bacteria (E Coli), which were identified in the Phase II NPDES MS4 Permit (EPA 2009) as the "Pollutants of Concern".

The outfall sampling locations (Figure 1 WC-1.200) is situated on the west bank of Willow Creek, approximately 1.2 miles upstream of the confluence with the Boise River. The outfall is elevated near the ordinary high water mark and is fitted with a cast-iron flap type tide gate. The 15-inch diameter PVC storm drain pipeline extends northward along North 4th Avenue West. The samples for Years 3 through 6 were collected at Outfall WC-1.200 that discharges to Willow Creek near North 4th Avenue West (Figure 1). In addition to wet weather sampling, this outfall was sampled during the dry weather screening presented in Section II.

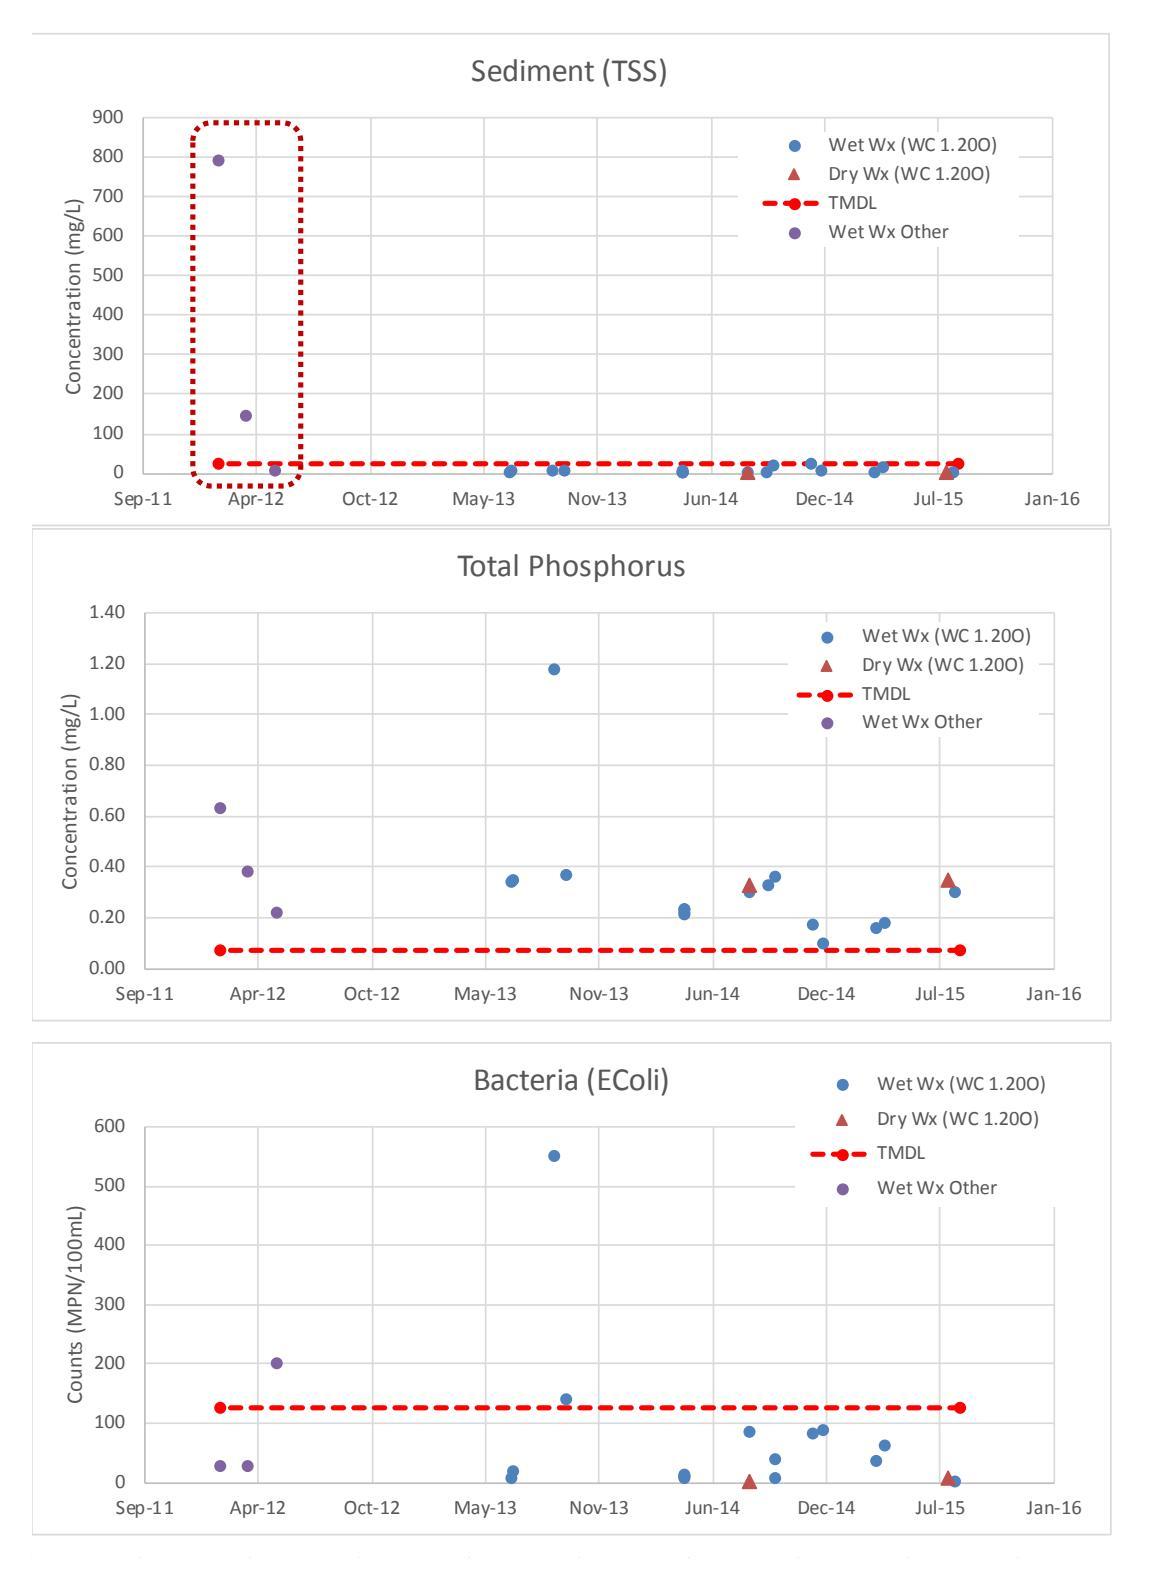
Figure 2 Water quality data collected for outfall WC1.200 since 2012

To support assessment of the water quality, the data collected since 2012 was plot for each of the pollutants of concern (Figure 2). Also shown water TMDL water quality targets that are applicable for either the Boise River or it's tributaries.

The water quality results indicated a lower level of variability in TSS levels in 2013 through 2014 compared to 2012 results. The highest concentration occurred in late January 2012. The 2012 March sample is also somewhat high, but the May 2012 and all other sample concentrations are relatively low. Generally tributaries to the Boise River show elevated levels in summer often due to increased agricultural runoff, with lower concentrations in the winter when groundwater is draining from the agricultural lands (USBR 2001 and USGS 2004). Based on the generally lower TSS concentrations, it appears source water for many of the samples is likely either groundwater or canal water, the latter water originating from Lucky Peak.

Total phosphorus (TP) concentrations are variable during each year, ranging from a low of 0.10 mg/L to a high of 1.18 mg/L in 2015 and 2013, respectively. An apparent correlation with sediment observed in 2012 is not evident in 2013. Due to the relatively high TP and low TSS concentrations, the more likely source appears to be associated with groundwater, and not canal water which have much lower TP (e.g., 0.02 mg/L as reported by MaCoy 2004).

Bacteria levels (i.e., E Coli counts) were relatively high in September 2013 and in May 2012. Relatively low counts were reported in January and March 2012, June 2013, and 2014. The geomeans was slightly higher in 2015 compared to 2012 and 2013.

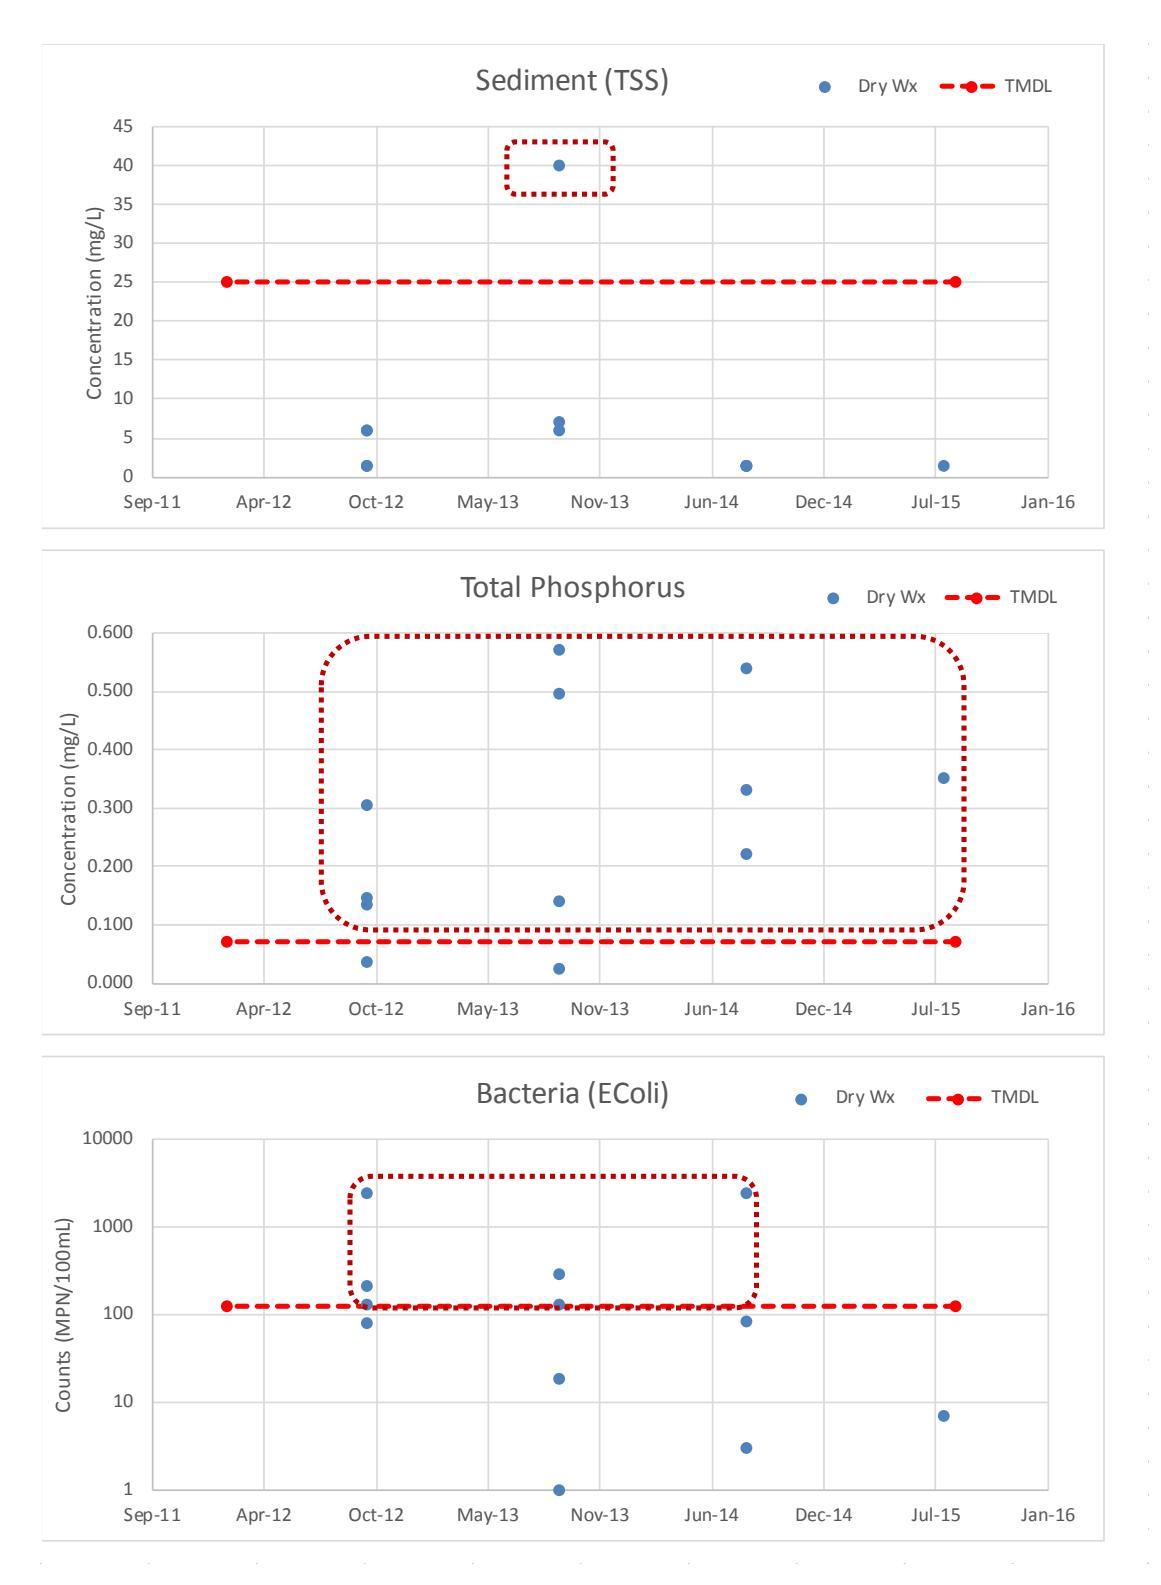
Figure 3 Water quality data collected during dry weather sampling since 2012. Note that TSS concentration of 896 mg/L for 9-11-2013 is not plotted.

Dry weather water quality samples were collected from 1 outfall (i.e., WC-1.200) on July 30, 2015. Field measurements and laboratory results are summarized in Tables 7, with laboratory data shown in Figure 3.

While data collected provide some indication of water quality, it must be noted that flow rates ranged from approximately 50 gpm to less than 0.10 gpm. The 2015 dry weather screening data (Figure 3) indicates quite low levels of sediment (TSS), with most results also below the 25 mg/L level. This is also the wet weather monitoring outfall and appears to be discharging shallow groundwater.

Counter to this, the phosphorus level was relatively high, but still within the range observed in the Lower Boise River watershed (e.g., MaCoy 2004). Similarly, most concentrations were above the Snake River-Hells Canyon TMDL target of 0.07 mg/L (IODEQ 2004).

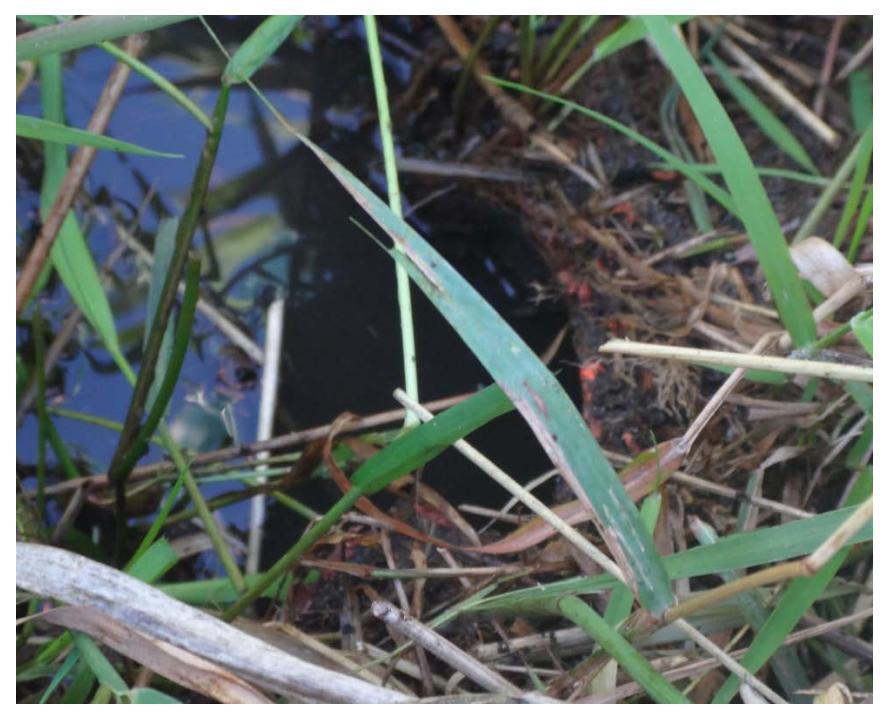
Figure 1: Outfall MS-0.840

This outfall directly connects to a catch basin located at the Southern point of S 1<sup>st</sup> Avenue East. The outfall is located on the north bank of the Mill Slough Canal and consists of a 6" CMP pipe that is accessible but is almost fully submerged below the water surface. It did not appear that any water was discharging from the outfall. No water samples were taken. The pipe appeared to be in good condition, but an accurate condition assessment could not be made. It is believed that the outfall could be partially filled with sediment.

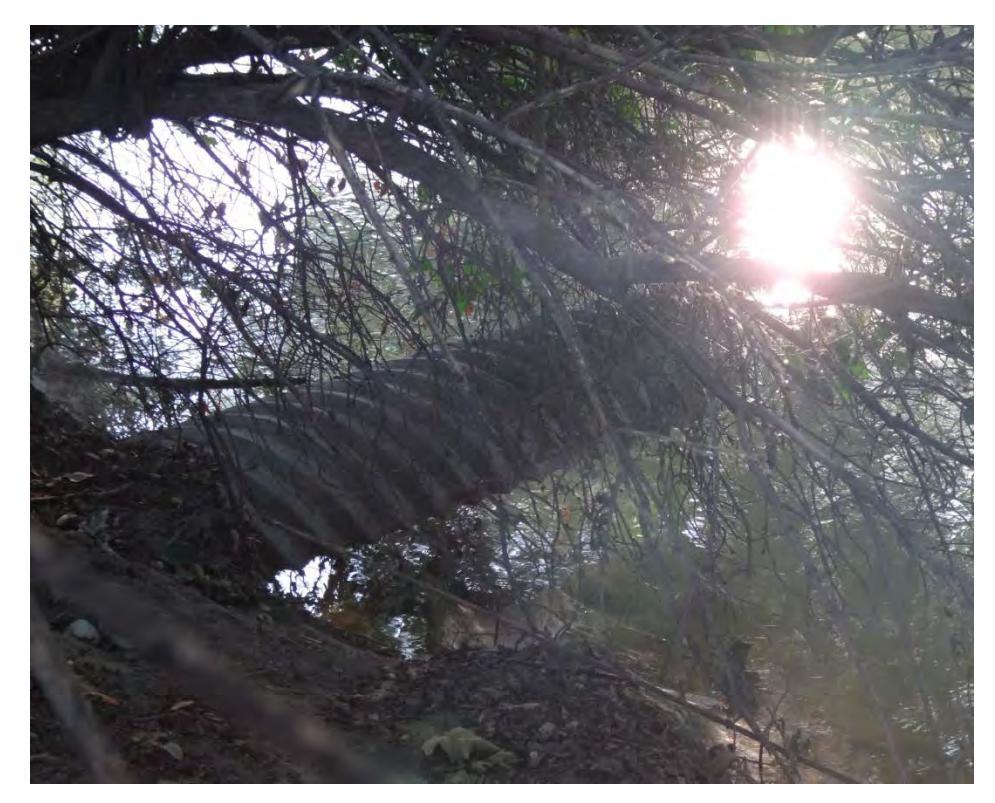
Figure 2: MS-0.970

This outfall is located on the north bank of the Mill Slough Canal east of S 1<sup>st</sup> Avenue East. The outfall directly connects to two catch basins on S 1<sup>st</sup> Avenue East and consists of 12" CMP pipe located above the high water mark. No water was witnessed discharging from the outfall into the canal. There were no signs of illicit discharge. The outfall appeared to be in good condition and no concerns were noted.

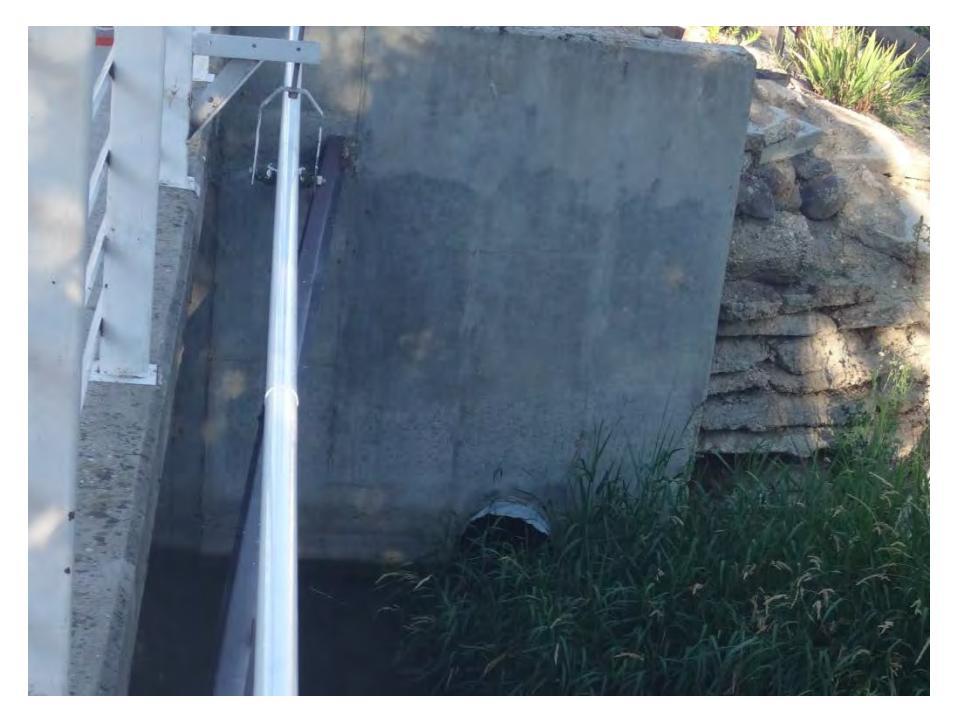
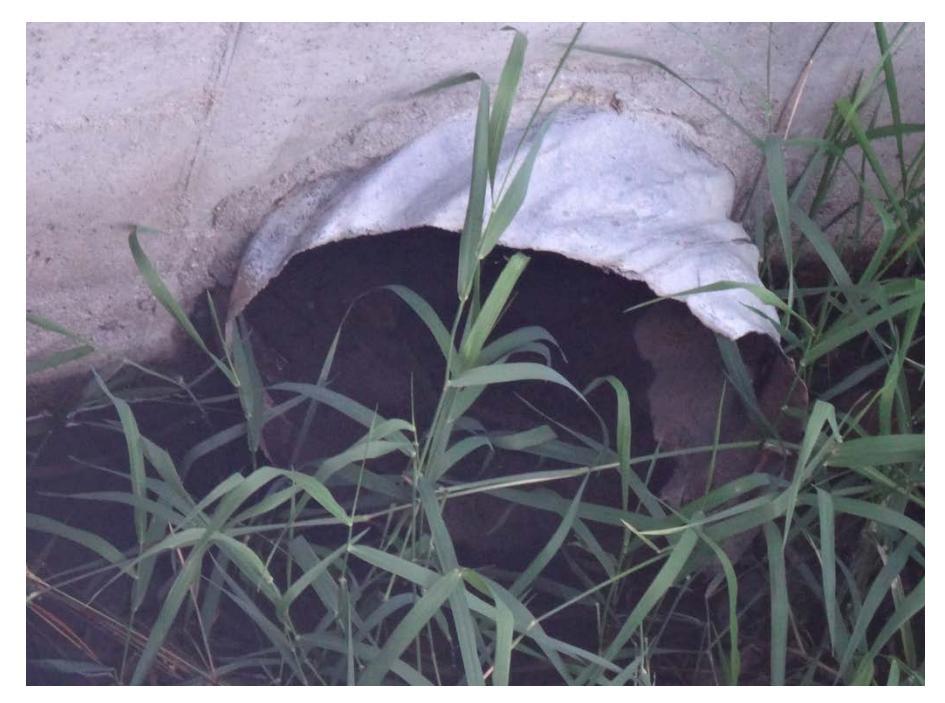
Figure 3: MS-1.010

This outfall is located at the west side of the canal bridge on Boise St. near the intersection with S 1st Avenue East. The outfall appears to be an approximate 18" CMP pipe. The pipe was partially submerged in the Mill Slough Canal at the time of our visit but there was no observed flow witnessed from the outfall. No water samples were taken. It is unknown where this outfall discharges from, but it is plausible that it is connected to the two catch basins at the intersection of Boise St. and S 1st Avenue East. Outfall MS-1.02 was believed to be connected to these catch basins, but could not be located.

Figure 4: MS-1.010 Partially Submerged

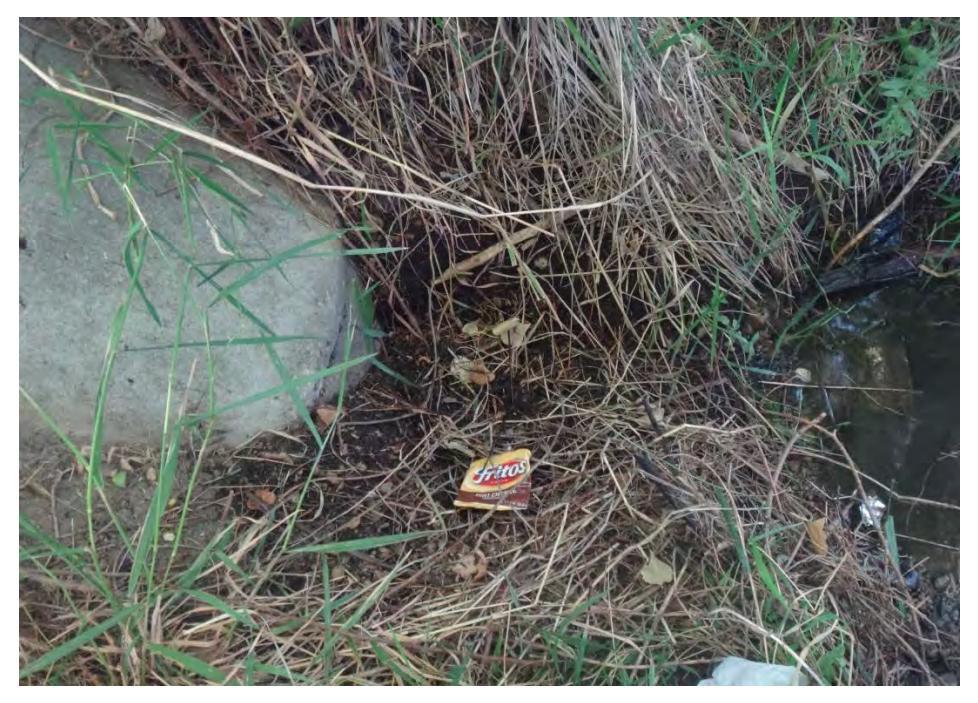
Figure 5: MS-1.150

This outfall is located on the south bank of the Mill Slough Canal just west of the intersection of S. Dewey Avenue and E. Idaho Street. It is unknown where the source of this outflow comes from. The outflow consists of a 10" diameter PVC pipe that is fully submerged in the Mill Slough Canal. There did not appear to be any flow from this outfall and no water samples were taken. The outfall appeared to be in good repair and no concerns were noted, but an accurate condition assessment could not be made.

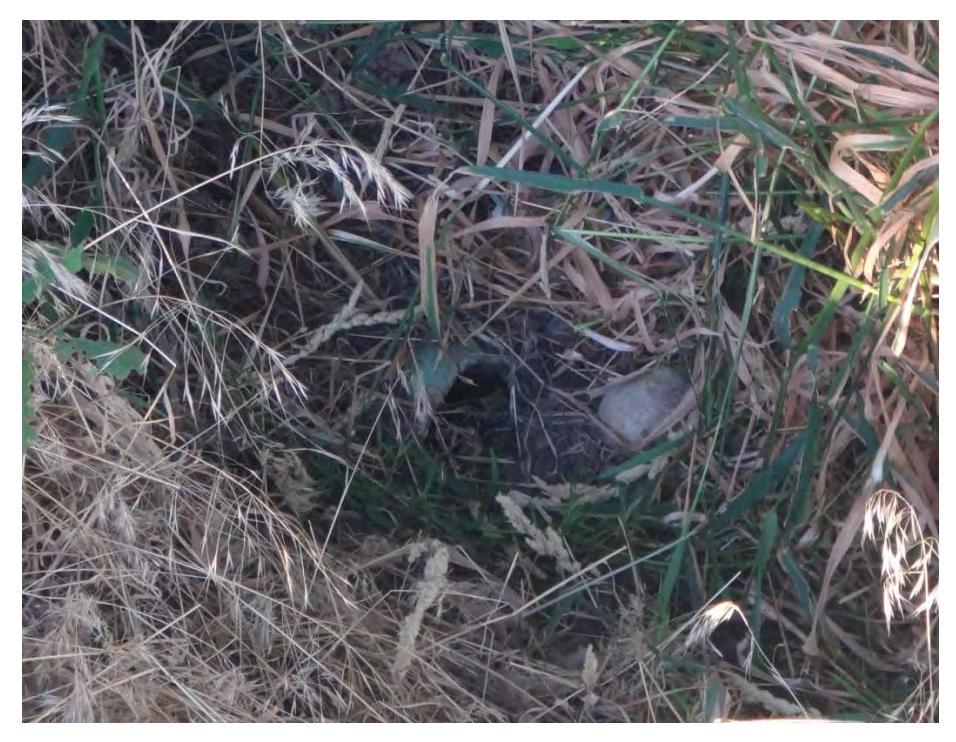
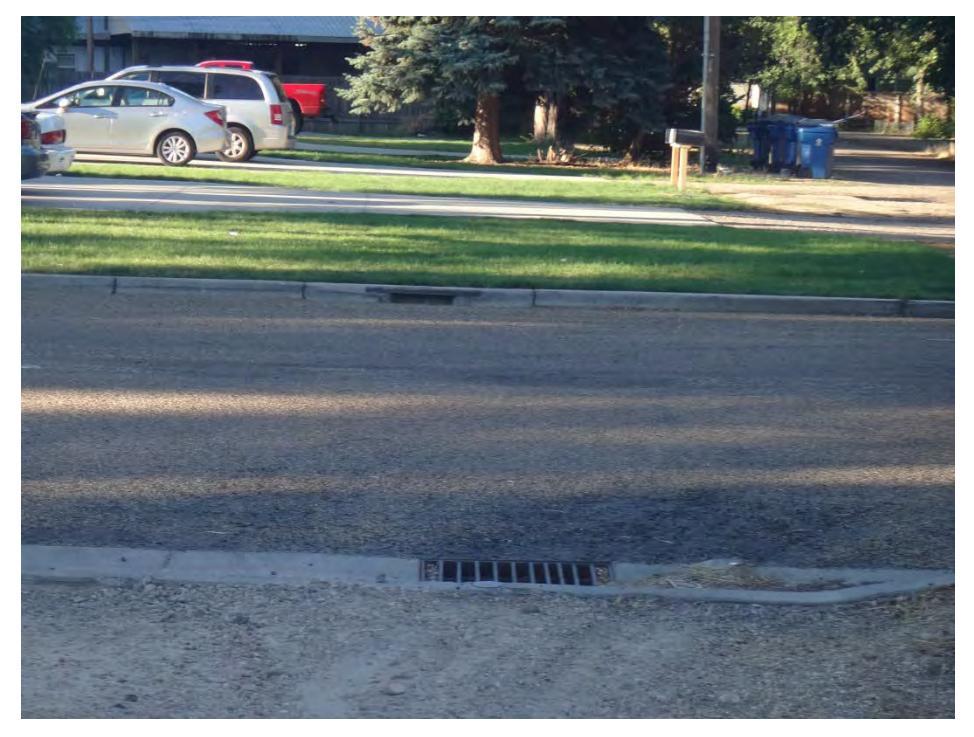
Figure 6: Outfall MS-1.170

This outfall is located on the south bank of the Mill Slough Canal just north of E. Idaho Street. The outfall directly connects to two catch basins located on E. Idaho St. and consists of 6" PVC pipe located above the high water mark. The outfall was overgrown by vegetation and the pipe is partially filled with sediment. No water samples were collected. The pipe appears to be in good conditions, but deposited sediment needs removed.

Figure 7: Outfall MS-1.170 Catch Basins

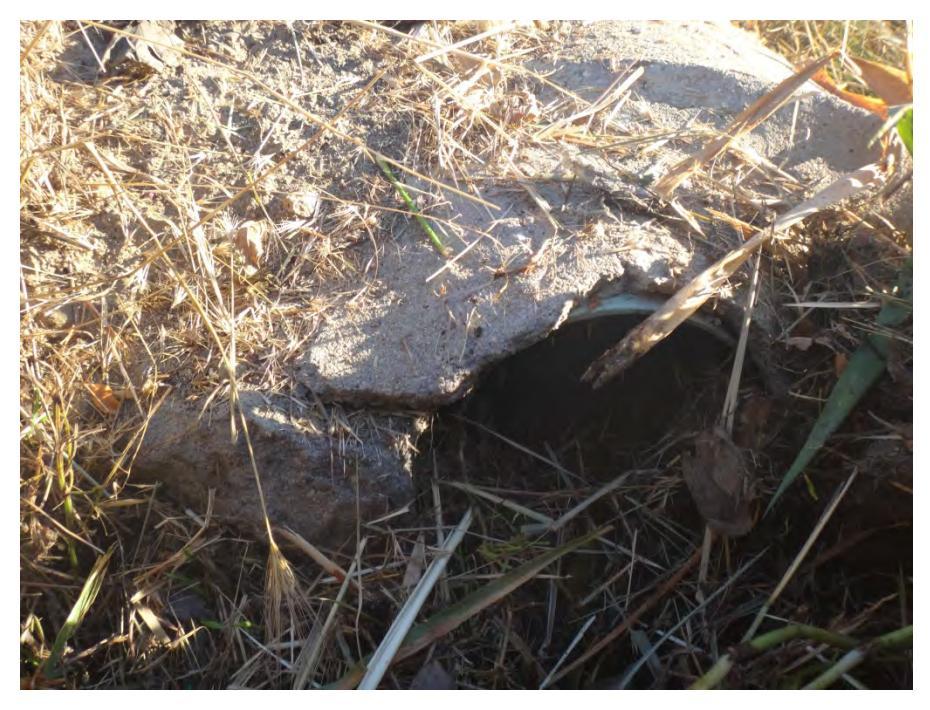
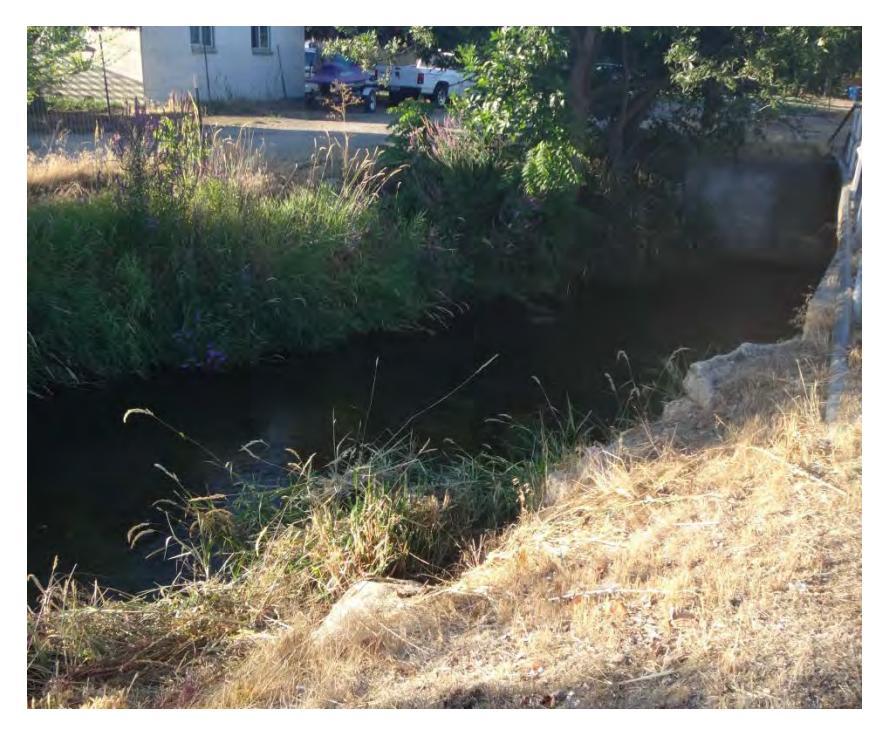
Figure 8: Outfall MS-1.180

This outfall discharges water from a catch basin located on the east side of S. Dewey Avenue. There was no observed flow from the outfall and no water samples were collected. The outfall consisted of a 6" PVC pipe and is located above the high water mark. The outfall is overgrown by vegetation and sediment appears to partially fill the pipe. The pipe is in good condition and no major concerns were noted but vegetation and sediment deposits need maintenance.

Figure 9: Outfall MS-1.180 location on canal bank

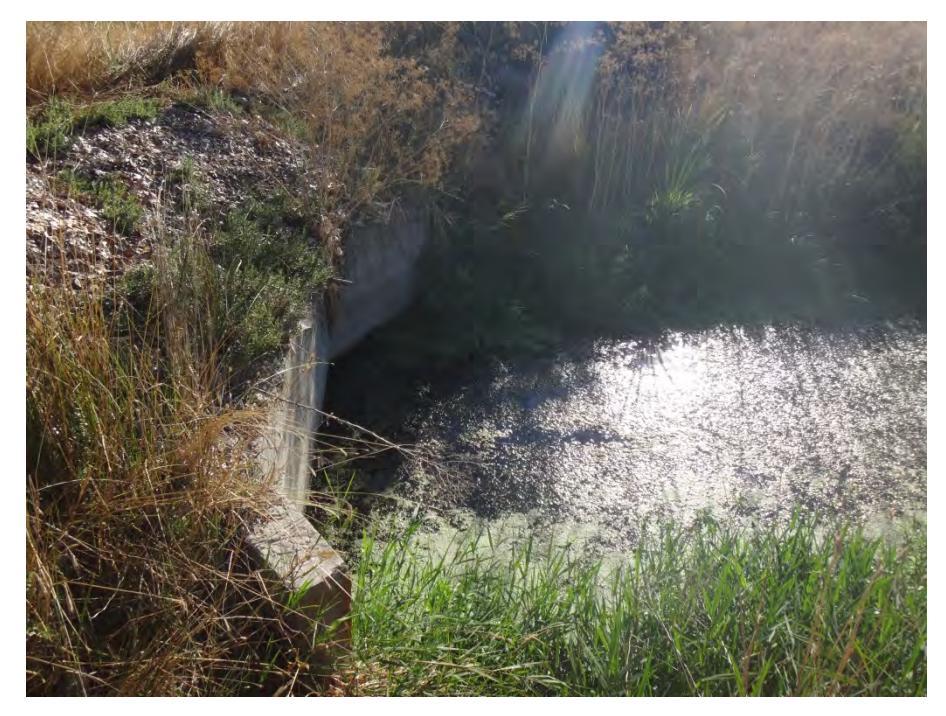
Figure 10: Outfall DD-0.89 Donna Drive Drain

This outfall is located east of Hawthorne Street near the west bank of Donna Drive Drain. We attempted to screen the outfall but could not locate it. It is believed that the Outfall pipe was dug up approximately 6 years ago, but the outfall is still in use. The outfall directly connects to a catch basin located on Donna Drive. It was mentioned that this catch basin has backed up many times in the previous years. Donna Drive Drain was partially filled with stagnant water indicating recent flows. This outfall will need to be located following recent rainfall and after location is marked dry weather screening will need to be accomplished.

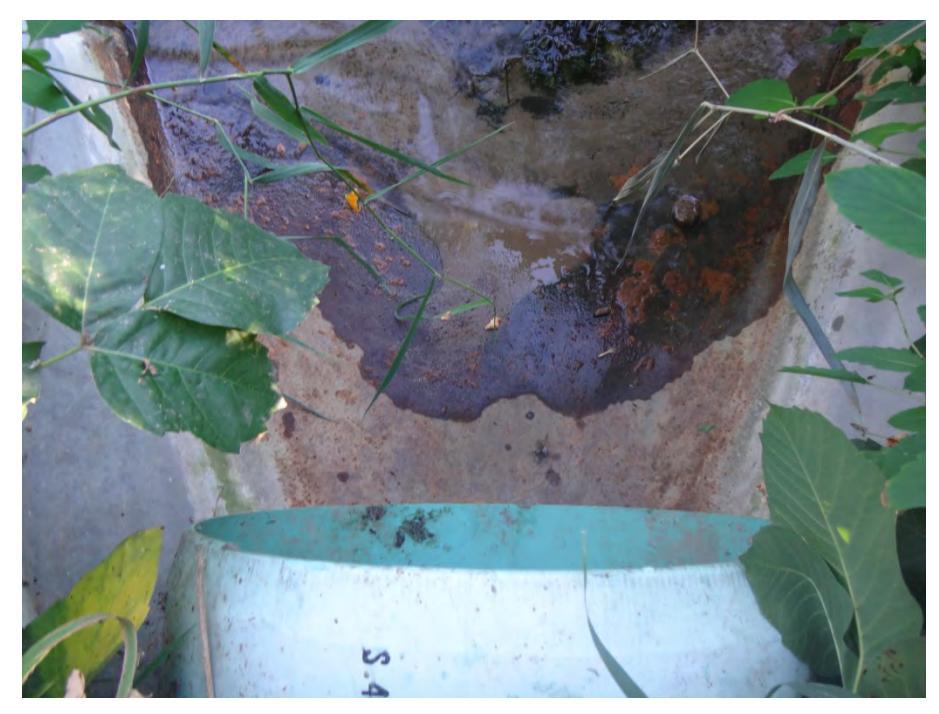
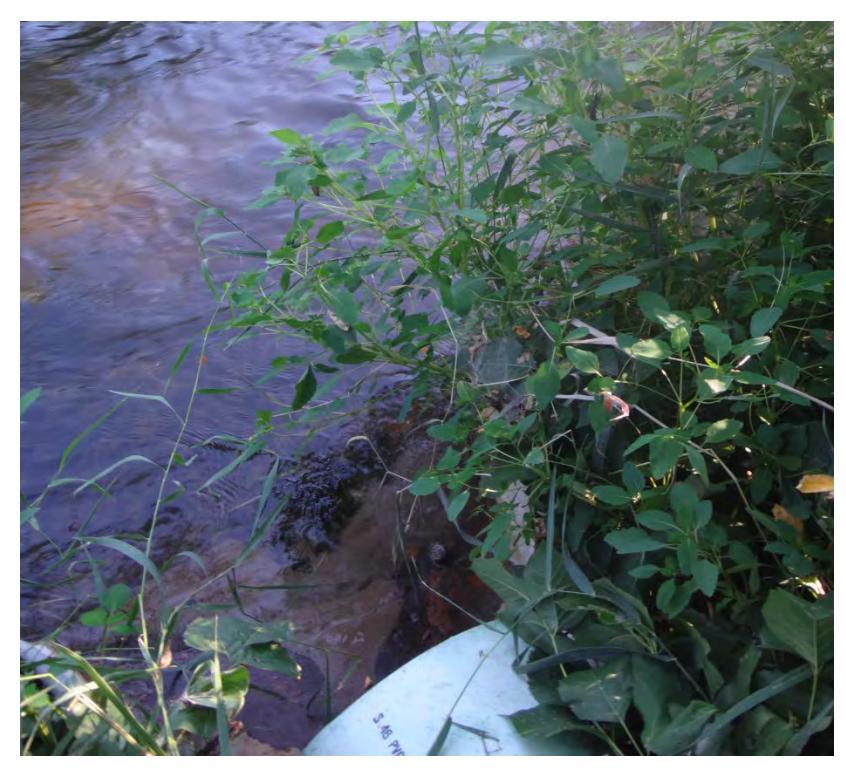
Figure 12: Outfall LK-1.10

This outfall is located on the south bank of the Lawrence Kennedy Canal west of the intersection of Crane Creek Way and South Middleton Road. The source of discharge is from a sand and grease trap located on the Crane Creek Way. The storm water flows from the sand and grease trap to the outfall via an open ditch located west of Crane Creek Way. The open ditch also appears to capture run-off from the landscaped area west of the roadway and may collect flow from a small portion of the adjacent field. This outfall consists of an 18" PVC pipe. There was no flow present at the outflow or in ditch, but there are stain deposits on the cement pad directly off the outflow that indicated the presence of past flows. No water samples were taken. The outfall appeared to be in good repair and no concerns were noted.

Figure 11: Outfall LK-1.10 flow indicator

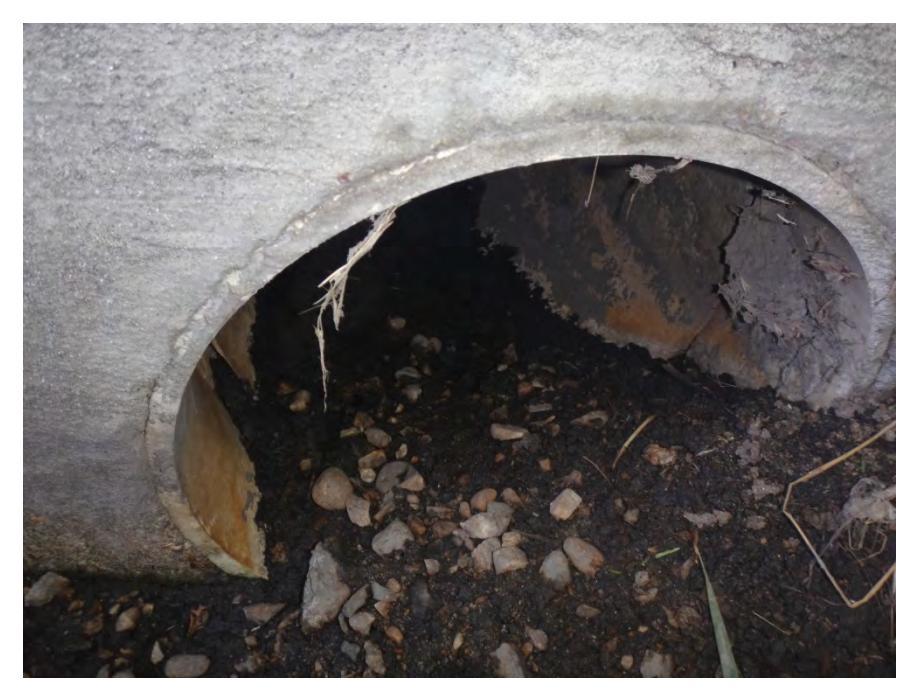
Figure 13: Outfall LK-1.12

This outfall is located on the south bank of the Lawrence Kennedy Irrigation Canal west of S. Middleton Road. The outfall consists of 12" PVC pipe and has no flow present. The water source is from two catch basins on South Middleton Road. The outfall is partially filled with sediment and has water flow marks present. The outfall appeared to be in good repair and no concerns were noted.

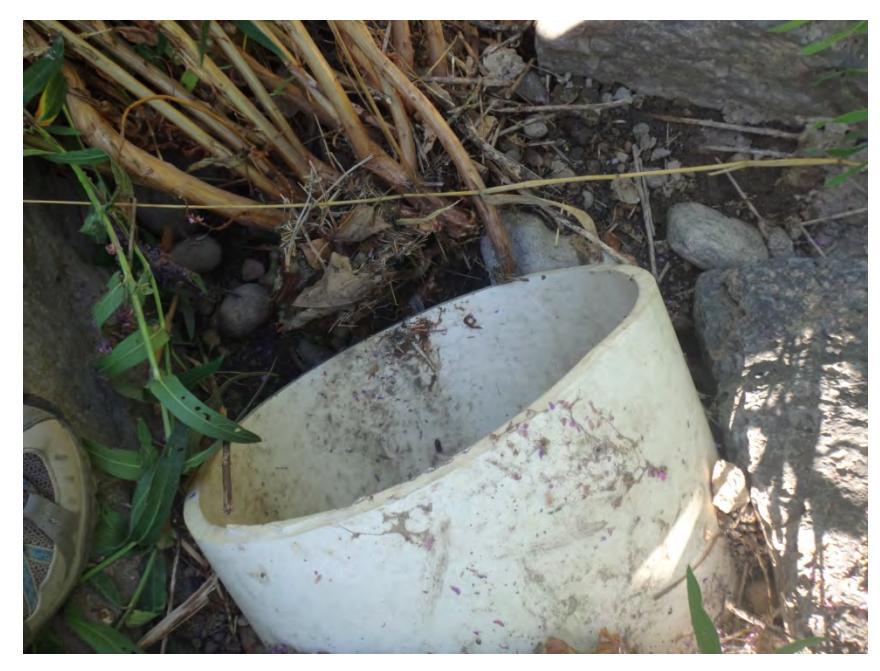
Figure 14: Outfall LK-1.13

This outfall is located on the north bank of the Lawrence Kennedy Irrigation Canal west of S. Middleton Road. The outfall directly connects to the catch basins located at the intersection of S. Middleton Road and Boise Street. There was no flow present and the outfall consisted of a 12" PVC pipe. There were no signs of illicit discharge. The outfall appeared to be in good repair and no concerns were noted.

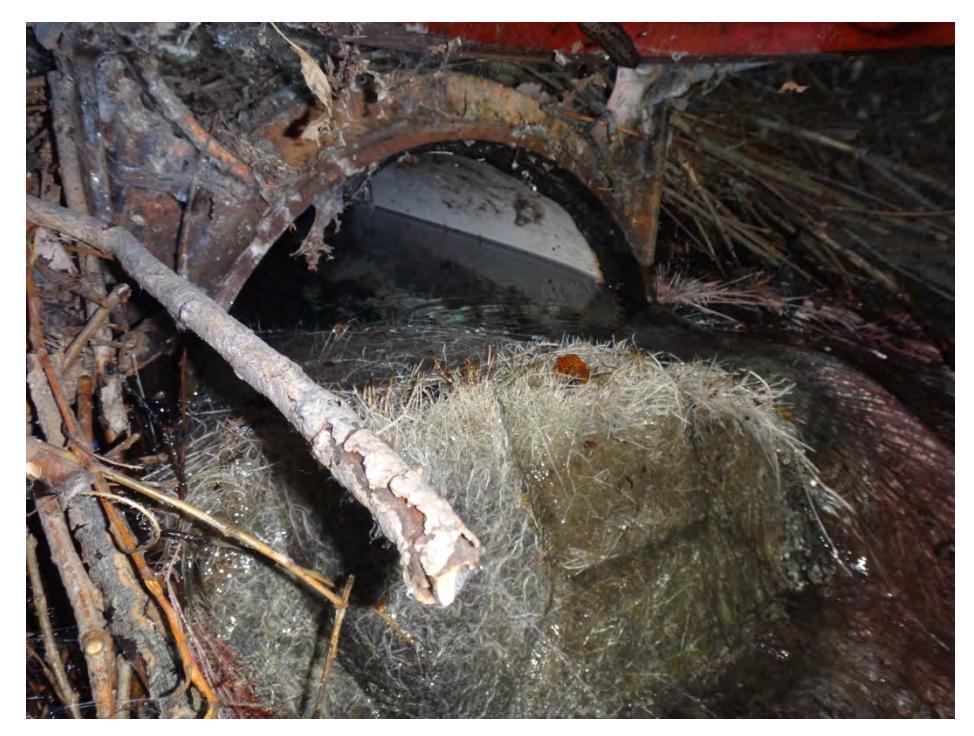
Figure 15: Outfall WC-1.20
Attachment - City Storm Water Ordinances

This outfall is the outfall used by the City to monitor storm water discharge quality for the NPDES stormwater permit. The outfall to Willow Creek is the terminus of a 15-inch diameter PVC storm line that extends north in N. 4<sup>th</sup> Ave. W. The outfall is situated on the west bank, approximately 1.2 miles upstream of the confluence with the Boise River. The outfall is elevated at or above the ordinary high water mark and is fitted with a cast-iron flap type tide gate.

During the 2015 screening a visual estimate of approximately 45-50 gallons per minute present was discharging to Willow Creek. There was no apparent sign of coloration or odor from the discharged flow. The source of water could not be determined. The outfall was over grown by willow tree roots. The pipe appears to be in good conditions, but vegetation needs removed. A water sample was taken at the outfall and was submitted for laboratory analysis. Results are provided in Attachment C.
